**ST. GEORGE'S ANGLICAN CHURCH**  
**One of The Four Churches of**  
**"SALVATION CORNERS"**  
**Owen Sound, Ontario, Canada**  
**February 2010**

The following is a summary of what was observed and what was discussed, *with additional comments*:

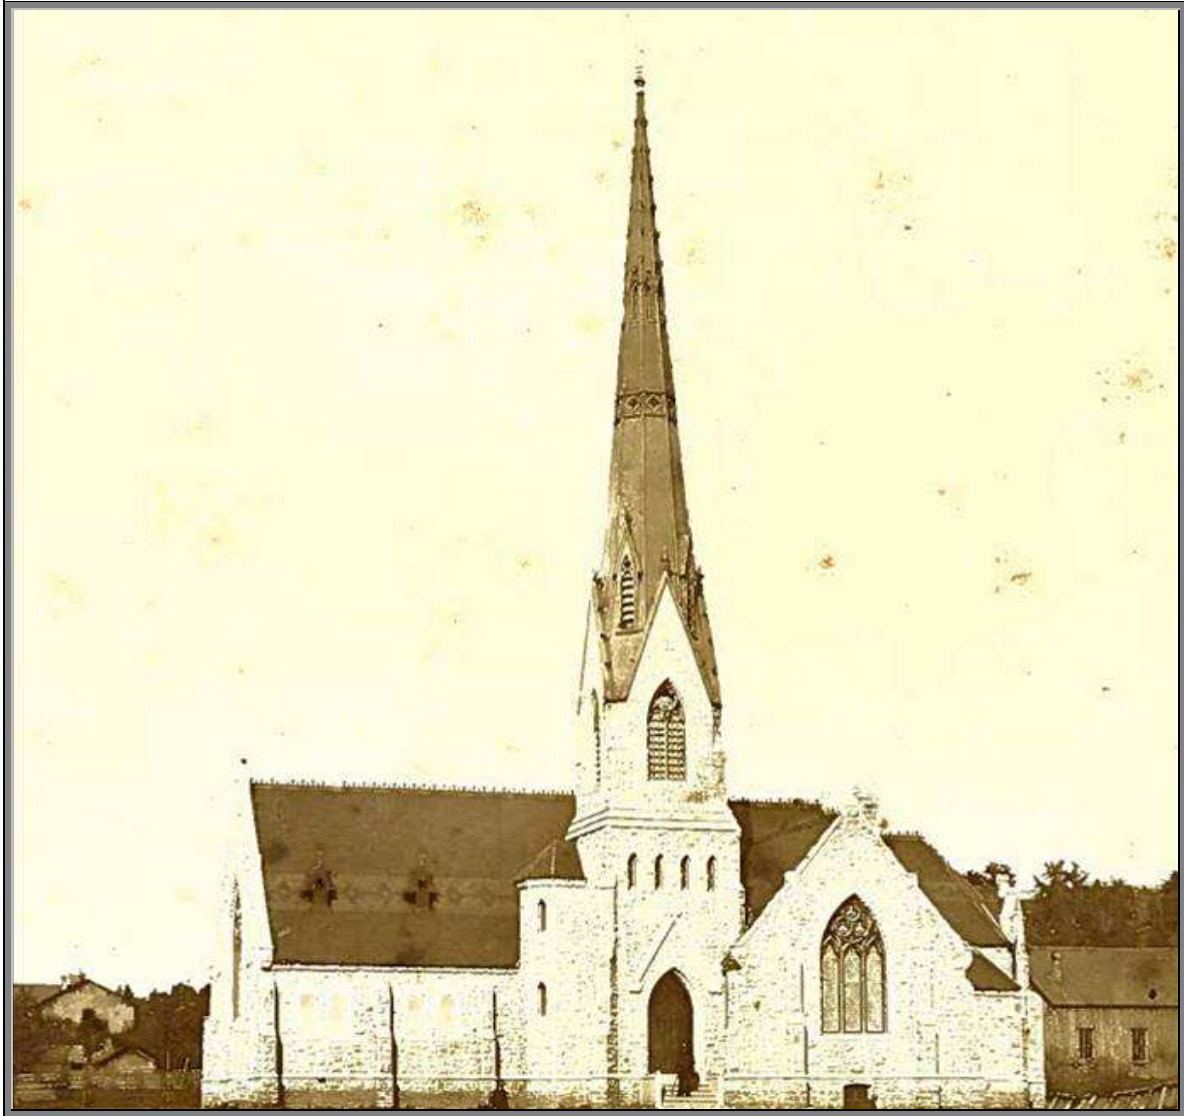
Taken shortly after the Church was built in **1881**, this photo shows the Church originally only had one door, located in the base of the Steeple, for the Congregation. *Originally there was only one other door into the Sacristy, for the Clergy.* This photo shows that the south front wall of the Sanctuary was originally built with only two bays between stone buttresses, extending westward from the Steeple, *left side of photo*. This photo also shows the west end of the Sanctuary, *left side of photo*, was originally a large gothic gable with a large gothic window similar to the one in the south transept to the right of the Steeple. The original decorative cast iron cresting, along the ridge of the main roof above the Nave and along the lower ridges of the roof above the Apse, is visible in this photo. This cresting was eventually removed. This old photo was taken from across the grand front lawn before any of the existing trees were planted.

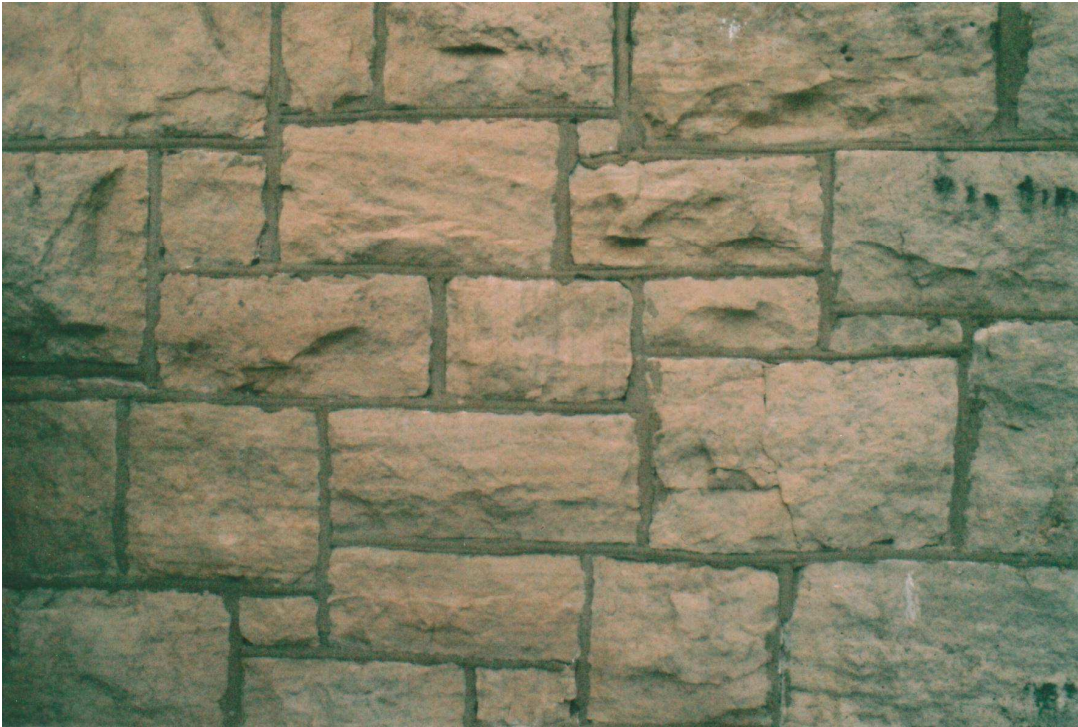
Detailed look at the Kingston stone on the 1881 Anglican Church

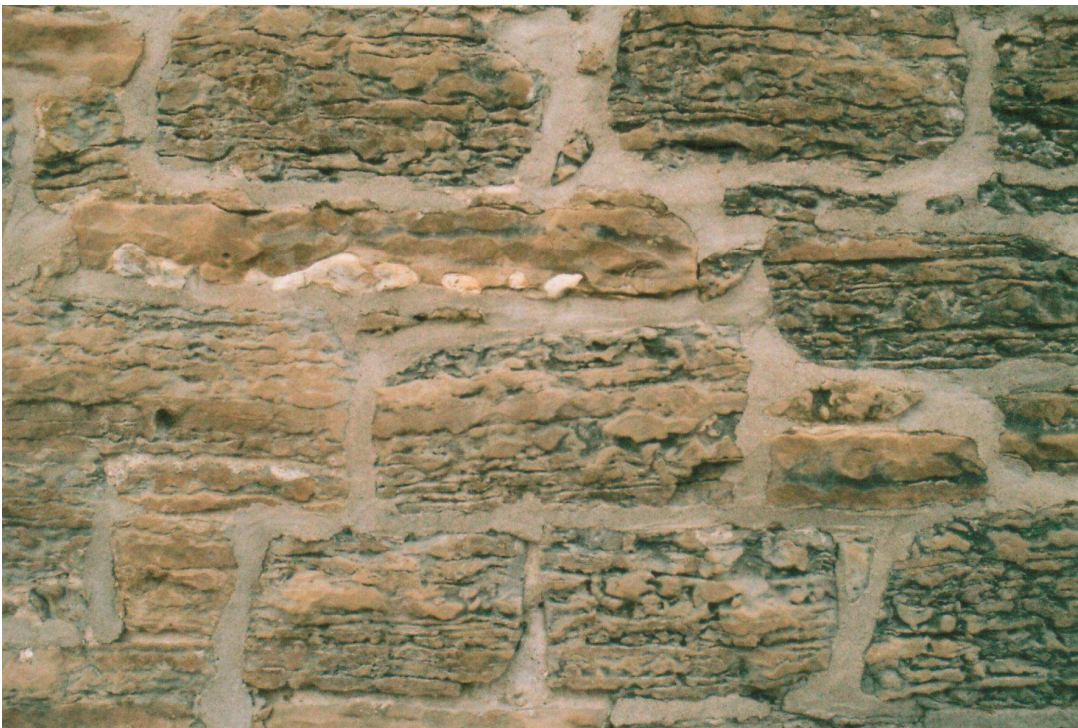
Detailed look at the local Bruce Peninsula stone on the 1898 Parish Hall

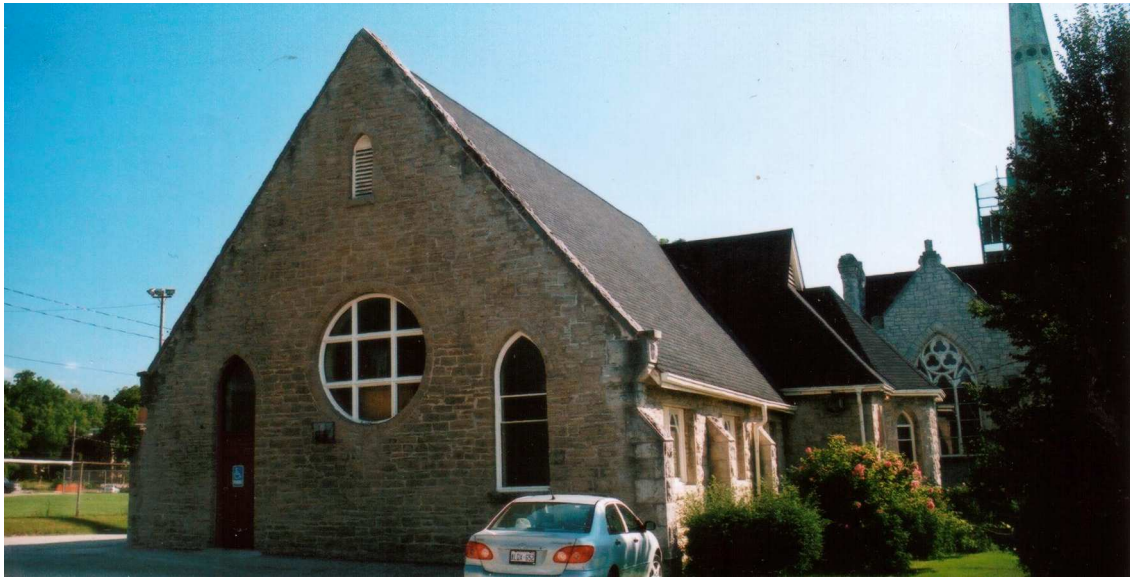
The Parish Hall's north gothic gable with nine square tracery in its rose window. The rose window is surrounded by a trinity of gothic arches. The gothic arch on the left is the "back" door which currently provides barrier-free accessibility into the main floor of the Parish Hall.

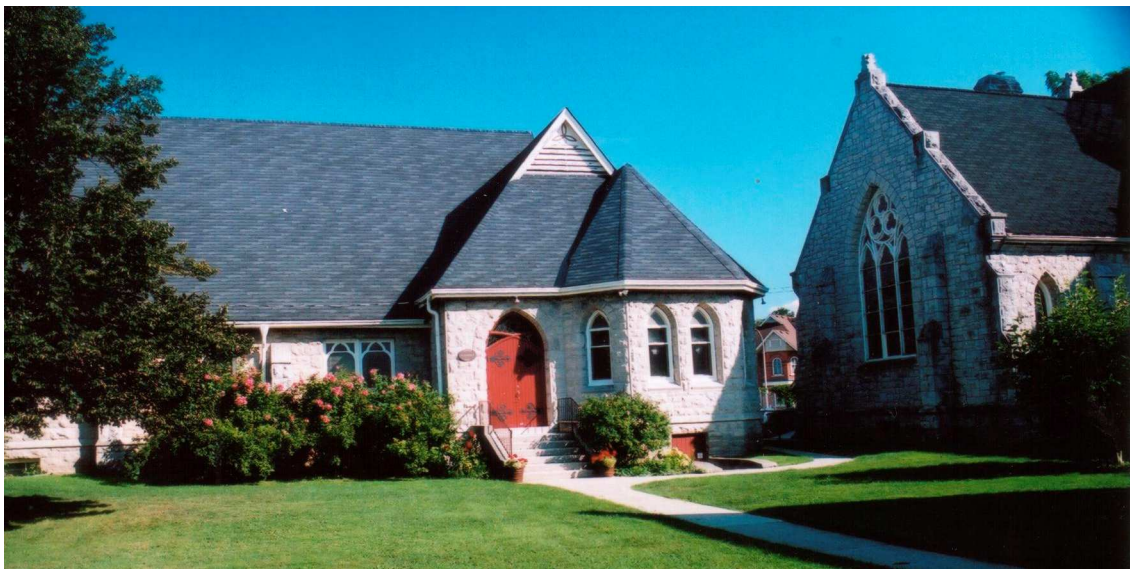
The hipped roofs of the north front and the south side of The Parish Hall were built in an aesthetically quieter Arts and Craft Style.

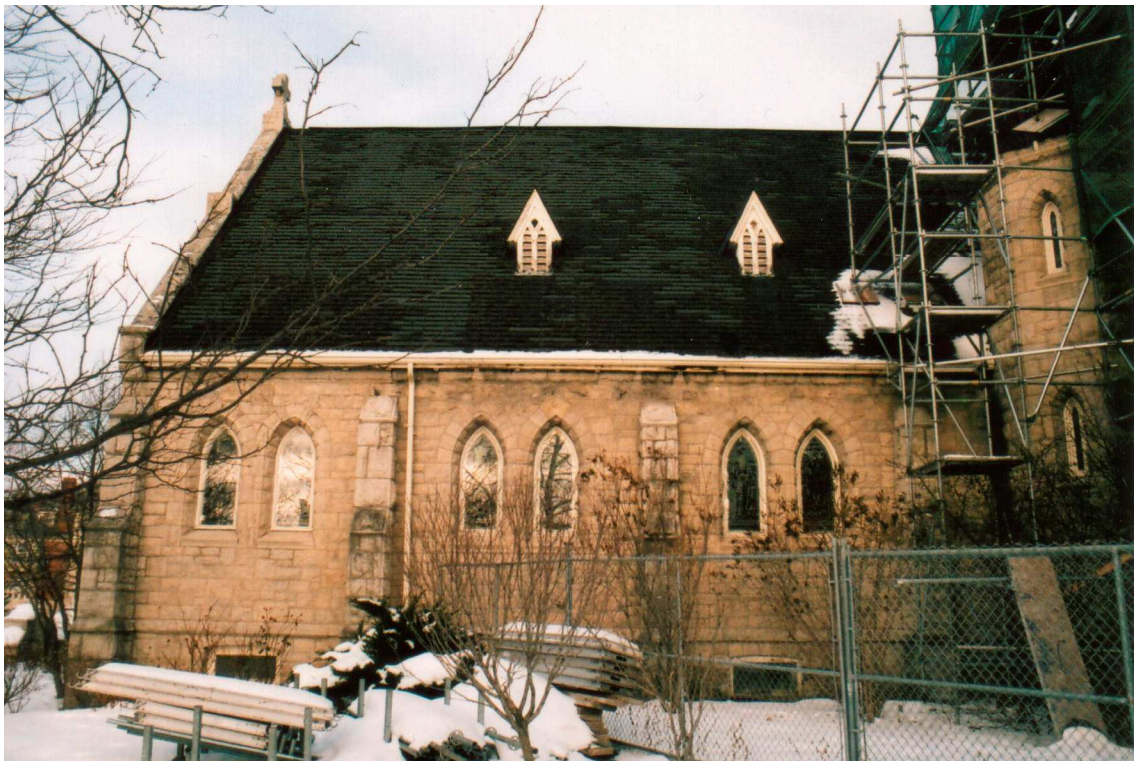
This photo shows three bays along the south front side of the Sanctuary's Nave. These three bays are located west of the Church's Steeple. The bay, on the left which was added in **1967**, is architecturally identical to the other two original **1881** bays, except for the missing ventilation dormer which was not put on the roof, when the bay on the left, was added in **1967**.

The Kingston stone of the Sanctuary  
and  
the local Bruce Peninsula stone of the back of the **1967** Narthex addition.

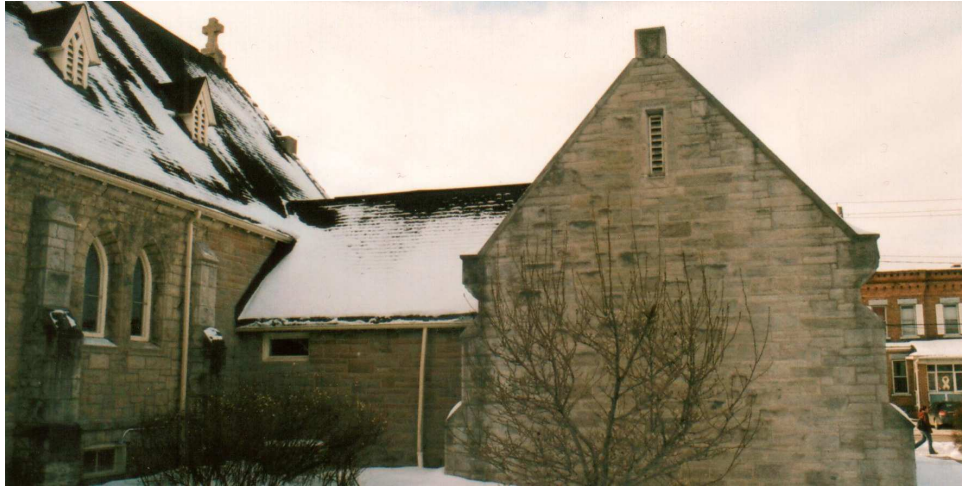
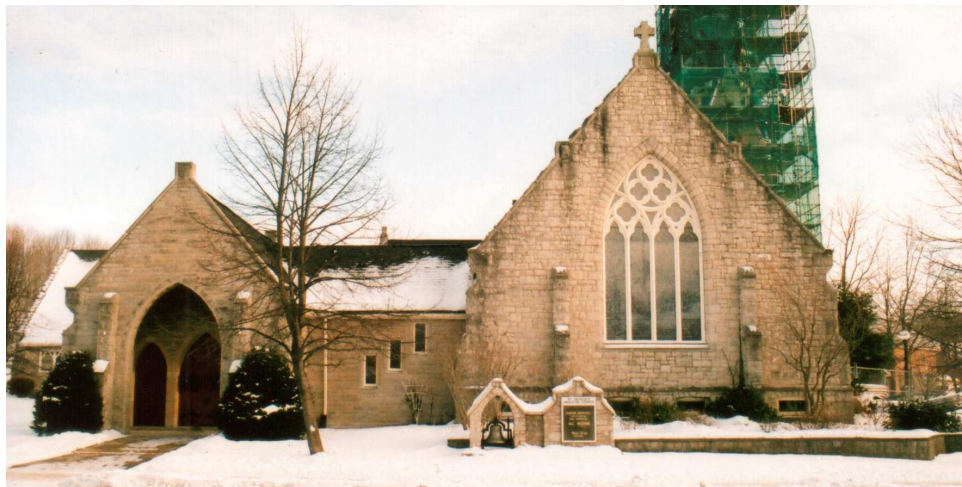
The larger north end gable of the Church's Nave  
was added in **1967**, Canada's Centennial Year.  
It was built from recycled and reclaimed Kingston stone.  
The lower link or hyphen and the smaller gabled Narthex entrance  
were built, from local Bruce Peninsula stone,  
at the same time in **1967**.  
The west Narthex entrance addition extends northward along Fourth Avenue East.

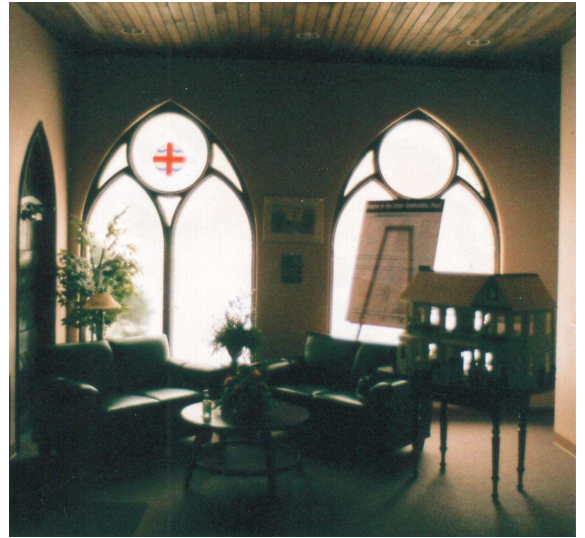
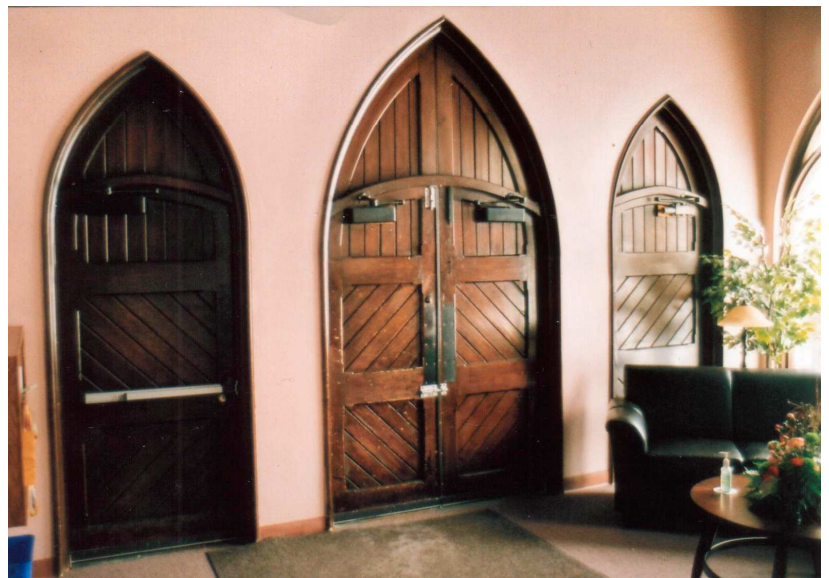
The exterior and interior detailing of the **1967** Narthex Entrance has a contextually feeling of belonging architecturally with the original **1881** Sanctuary.

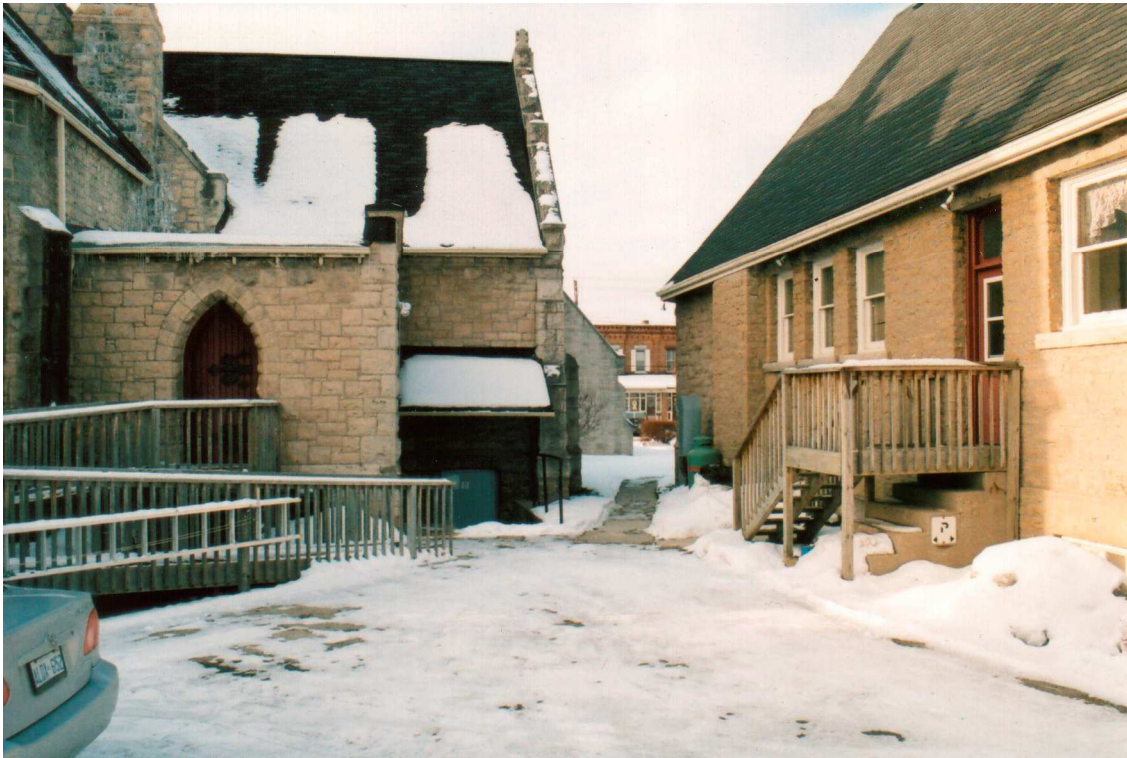
The existing curved pointed gothic door into the Sacristy and the existing exterior wooden ramp, *on the left*, are located to the east or “rear” of the Church Building.

The existing residential looking door with the square transom window above it and the exterior wooden stairs, *on the right*, are located on the south side of the Parish Hall.
